**Survey and Documentation Services  
12<sup>th</sup> Street Landfill Site  
Wilmington, Delaware**

**(Schnabel Reference 00151122)**

Subject: Contract 00151122, Survey and Documentation  
Services, 12<sup>th</sup> Street Landfill Site, Wilmington,  
Delaware

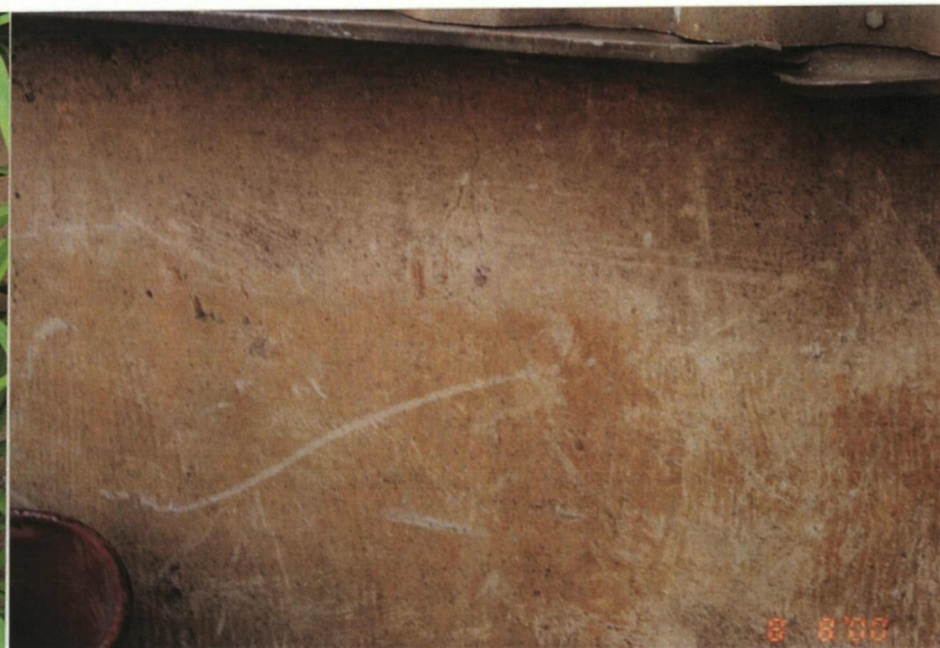
Photo 12

| Roll #1 | Photograph | Description |
|---|---|--|
| | 12. | H.L cracks between garage doors 1 & 2 in foundation wall between 2 and 4 feet long ~ 15' left of Garage door 2. |

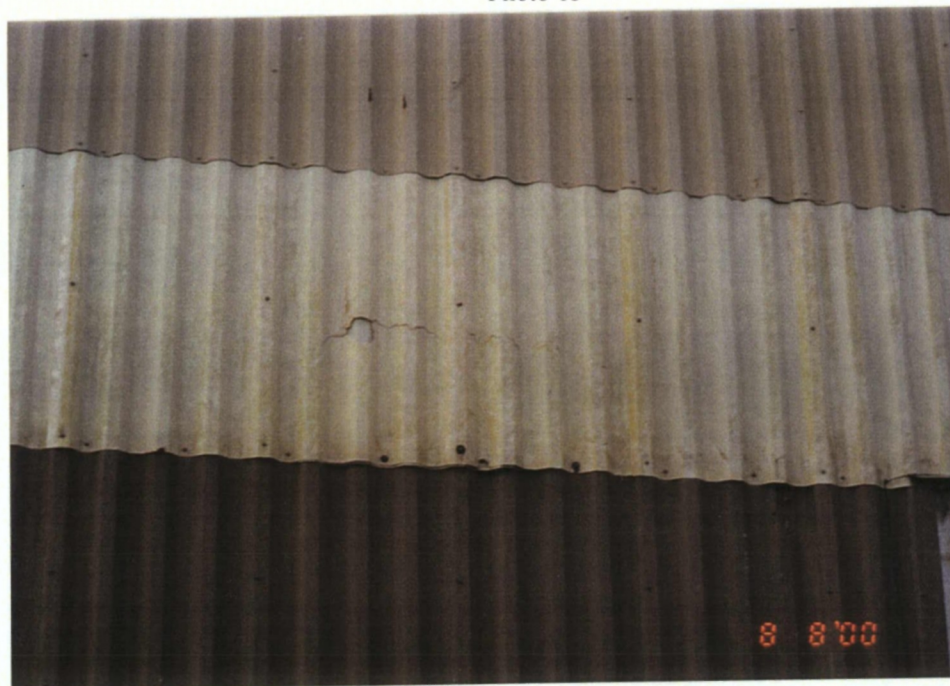
Photo 13

| Roll #1 | Photograph | Description |
|---|---|--|
| | 13. | Cracked siding to upper left of Garage door 2 |

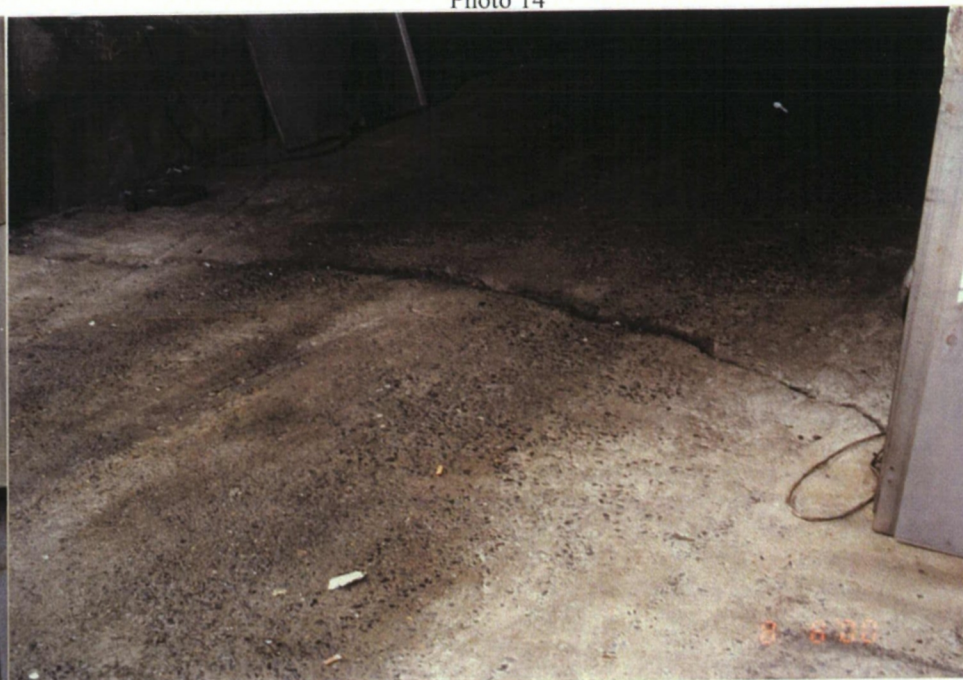
Photo 14

| Roll #1 | Photograph | Description |
|---|---|--|
| | 14. | Garage door 2 driveway slab crack about 8 to 10 feet long. |

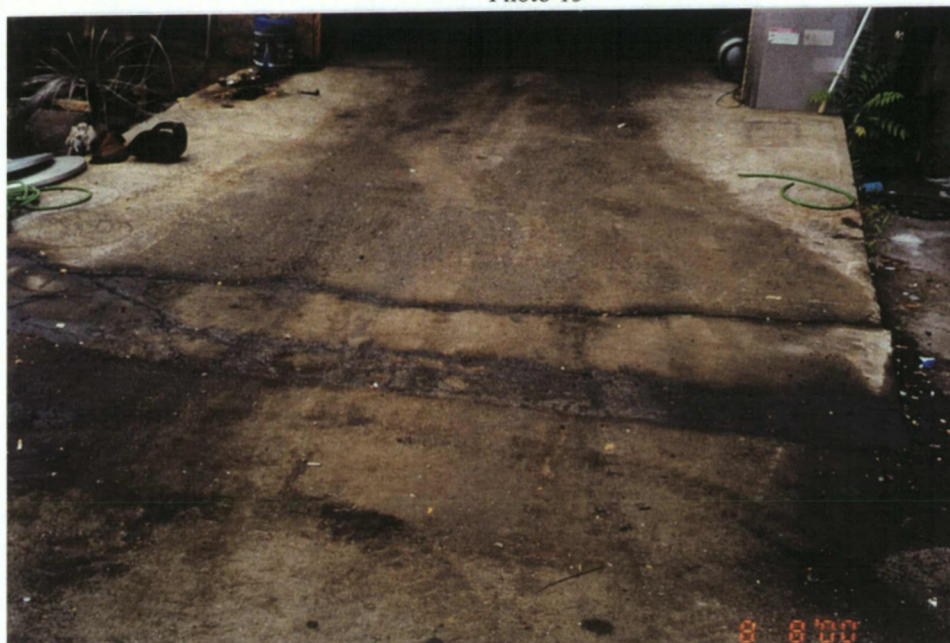
Photo 15

| Roll #1 | Photograph | Description |
|---|---|--|
| | 15. | Garage door 2 driveway slab crack about 8 to 10 feet long. |

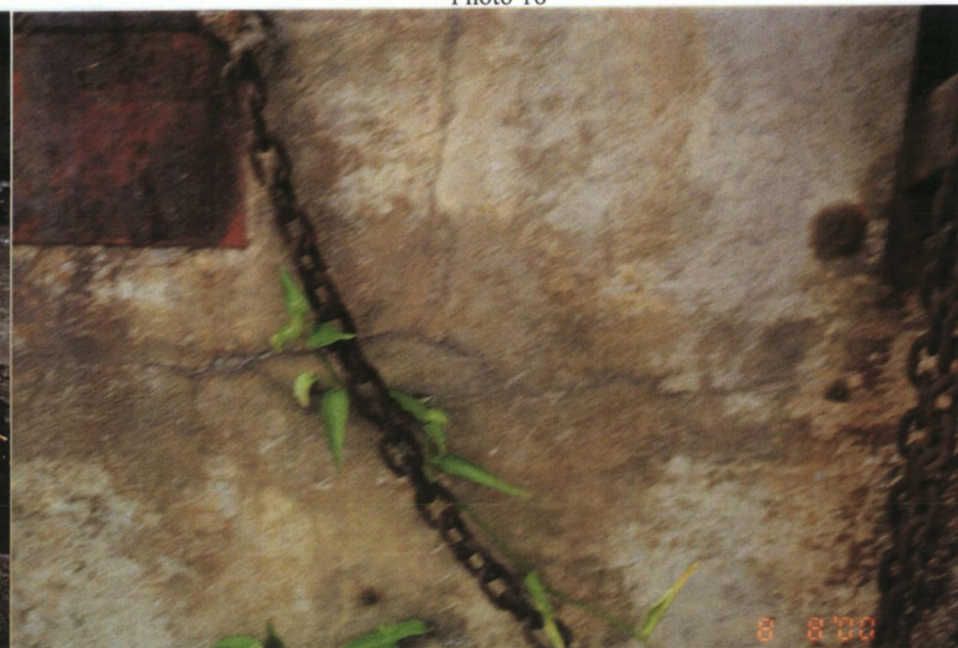
Photo 16

| Roll #1 | Photograph | Description |
|---|---|--|
| | 16. | H.L. crack bottom right of Garage door ~2' long |

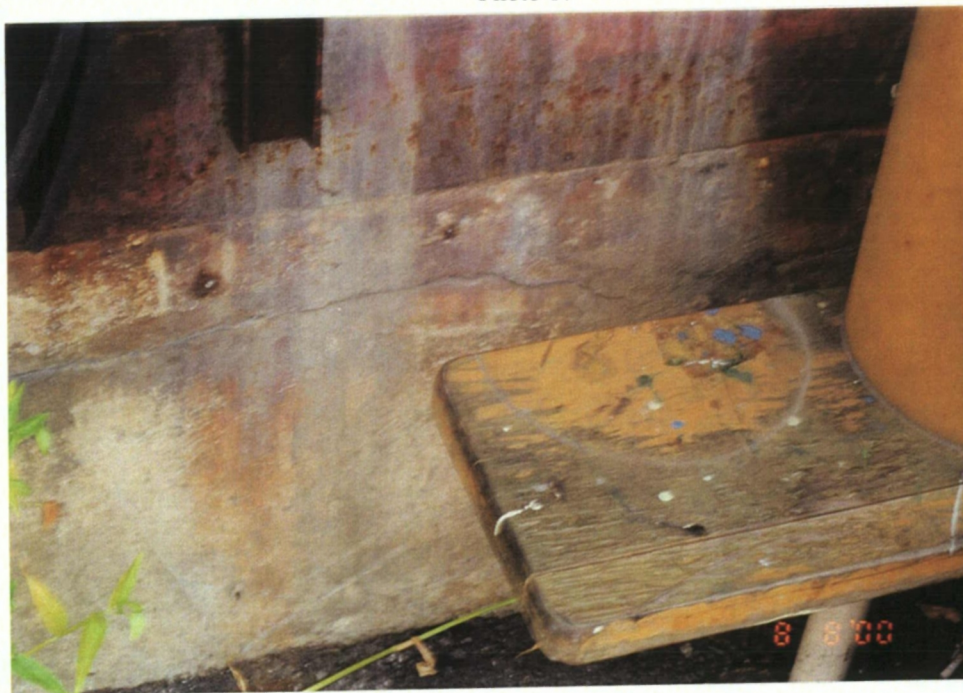
Photo 17

| Roll #1 | Photograph | Description |
|---|---|--|
| | 17. | H.L crack under Garage door 4 about 3 to 4 feet long |

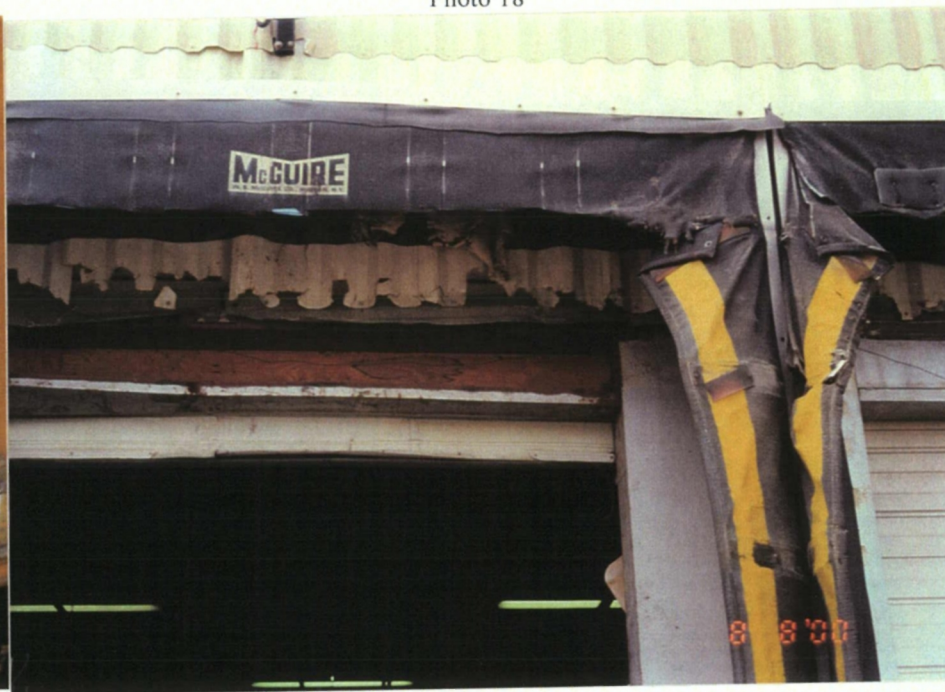
Photo 18

| Roll #1 | Photograph | Description |
|---|---|--|
| | 18. | Damaged siding above Garage door 3 |

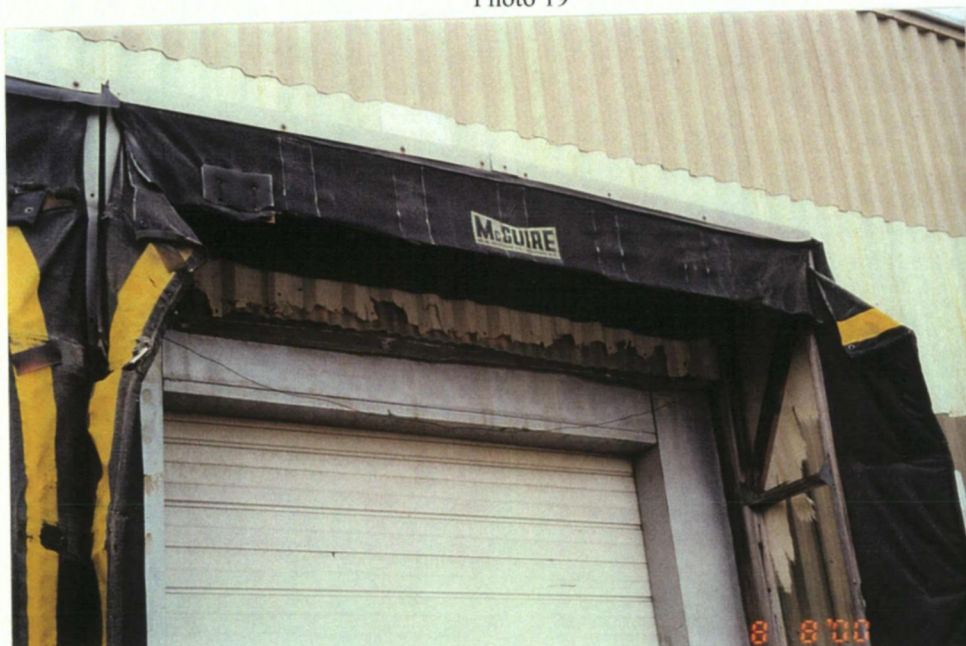
Photo 19

| Roll #1 | Photograph | Description |
|---|---|--|
| | 19. | Damaged siding above Garage door 4 |

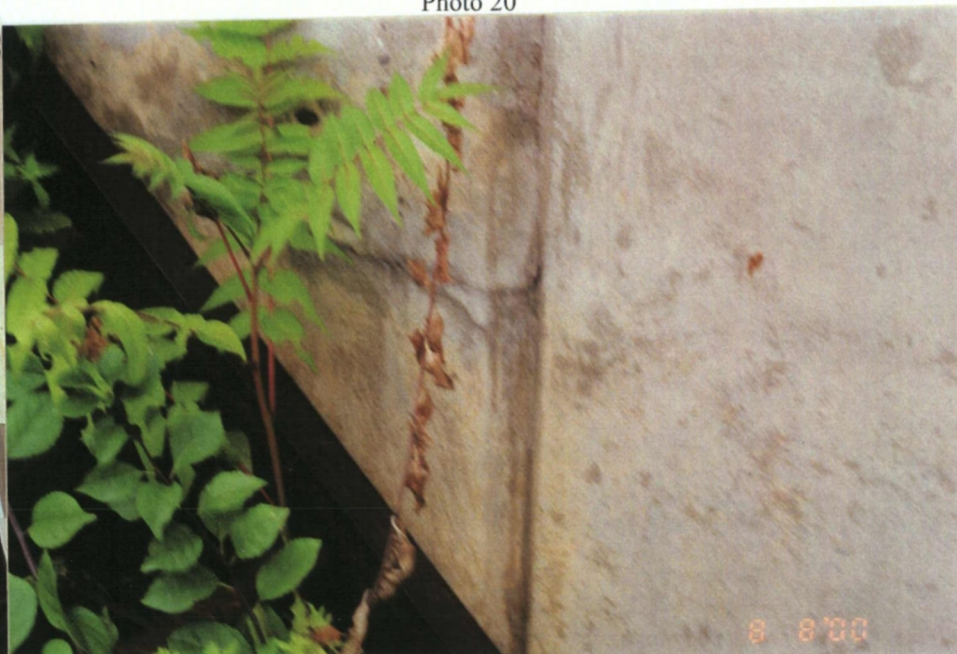
Photo 20

| Roll #1 | Photograph | Description |
|---|---|--|
| | 20. | H.L crack just right of door way next to stairs between 1 and 3 feet long |

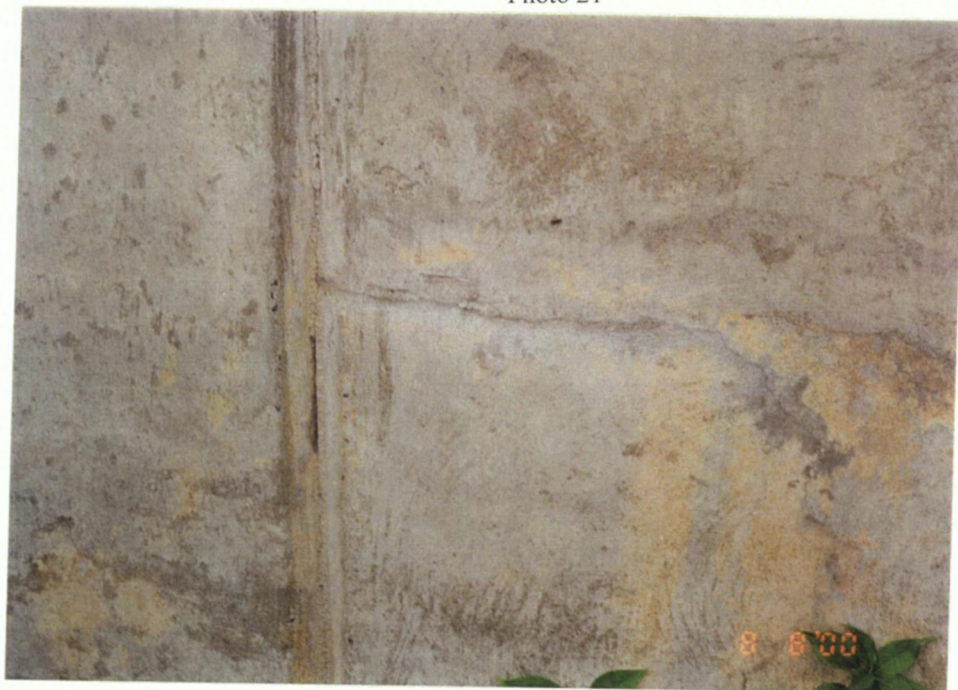
Photo 21

| Roll #1 | Photograph | Description |
|---|---|--|
| | 21. | H.L crack just right of door way ~2' right of stairs between 1 and 3 feet long |

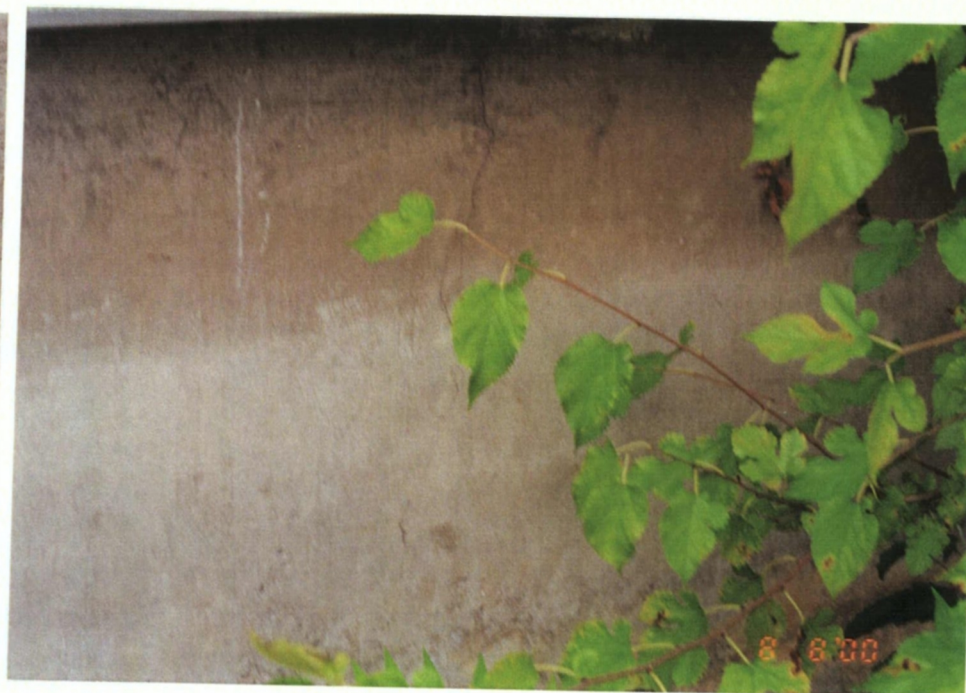
Photo 22

| Roll #1 | Photograph | Description |
|---|---|--|
| | 22. | H.L crack just right of door way ~5' right of stairs between 1 and 3 feet long |

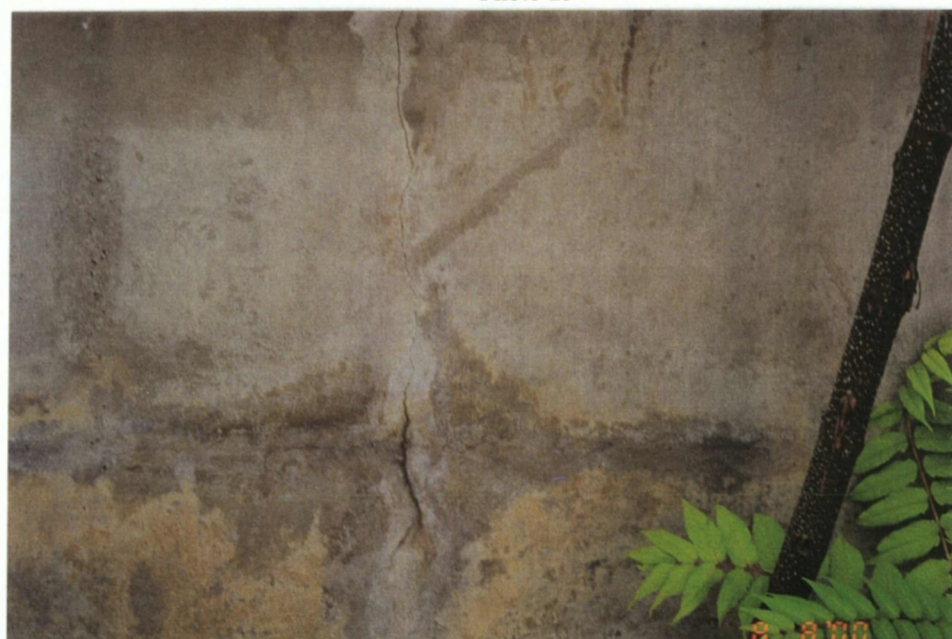
Photo 23

| Roll #1 | Photograph | Description |
|---|---|--|
| | 23. | H.L crack at about center line between door way and addition |

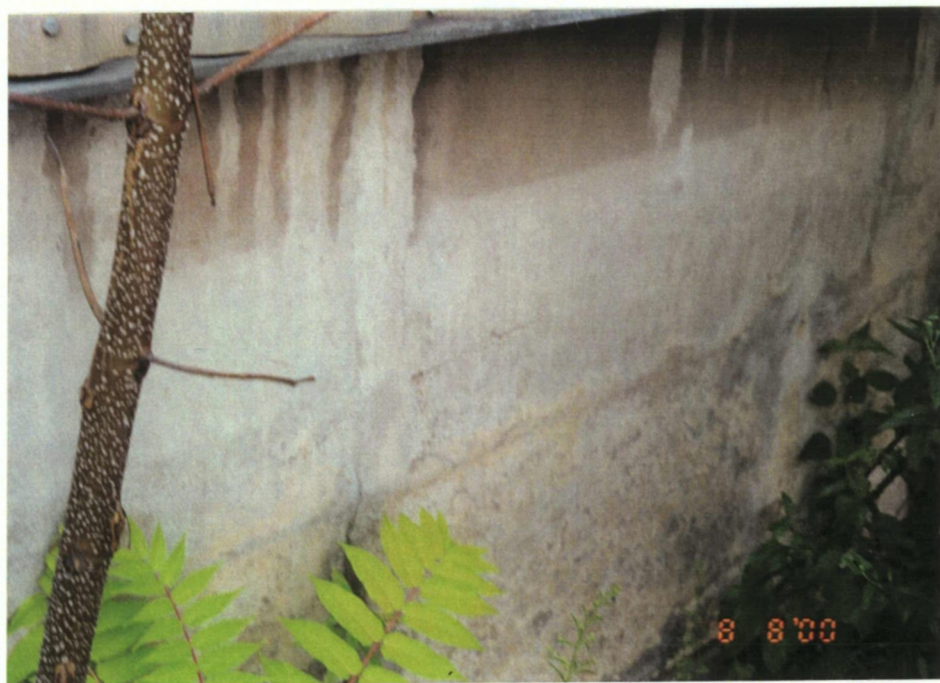
Photo 1

| Roll #1 | Photograph | Description |
|---|---|--|
| | 1. | H.L crack 2 to 3 feet long, ~16' left of addition, #2 ~ 14' left of addition |

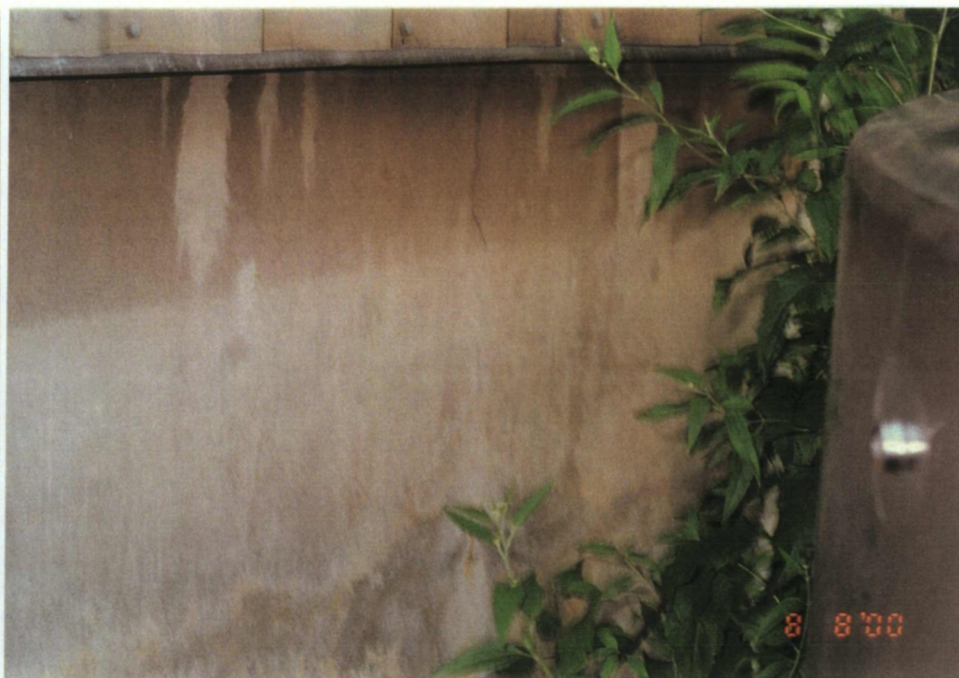
Photo 2

| Roll #1 | Photograph | Description |
|---|---|--|
| | 2. | H.L crack 2 to 3 feet long, ~ 14' left of addition |

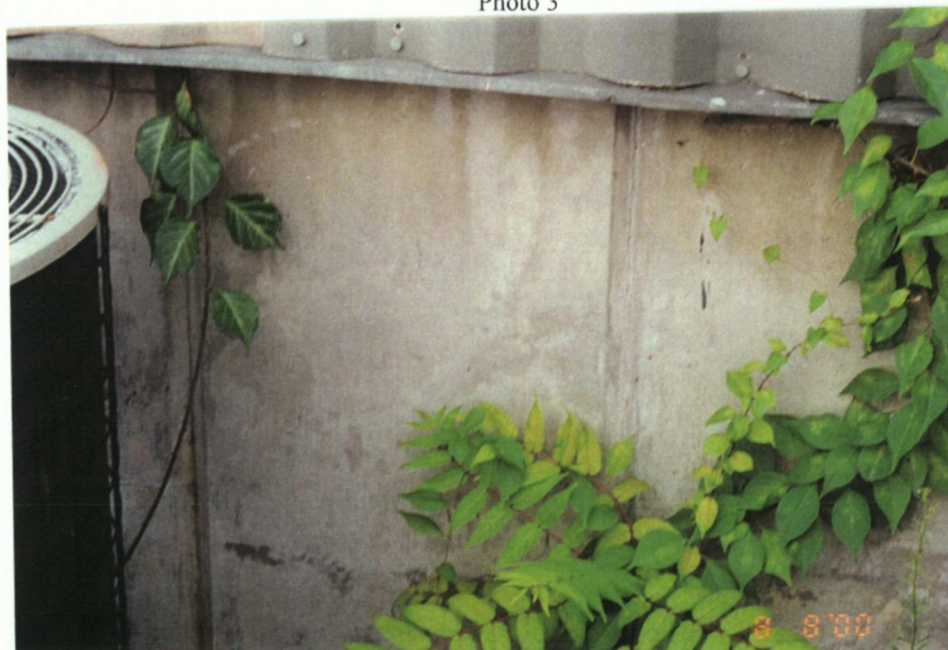
Photo 3

| Roll #1 | Photograph | Description |
|---|---|--|
| | 3. | Two H.L cracks down the center of settling joints left of addition ~ 3' long |

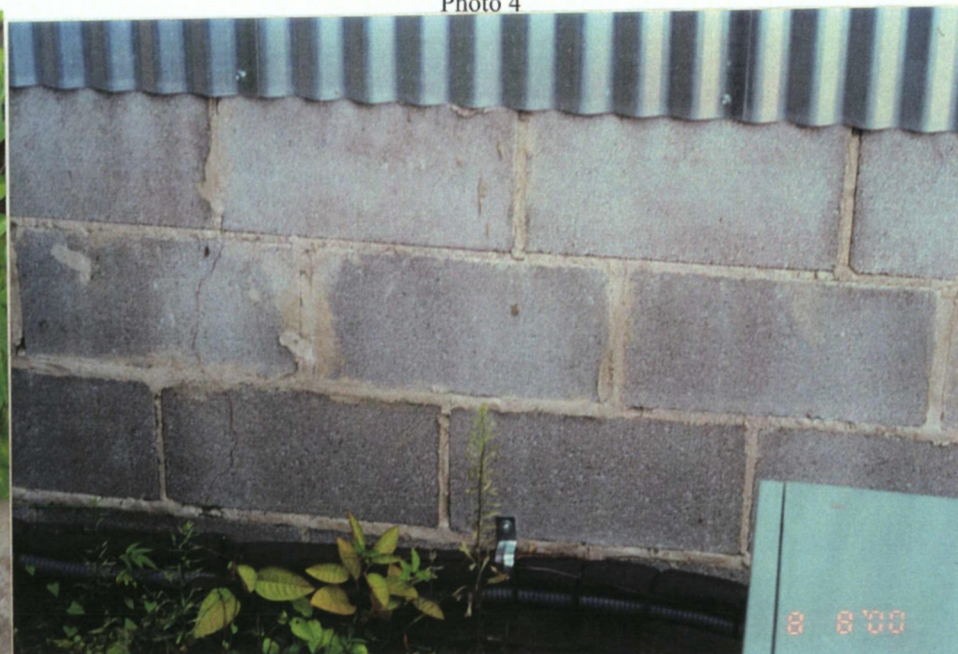
Photo 4

| Roll #1 | Photograph | Description |
|---|---|--|
| | 4. | Mortar joint cracks on addition |

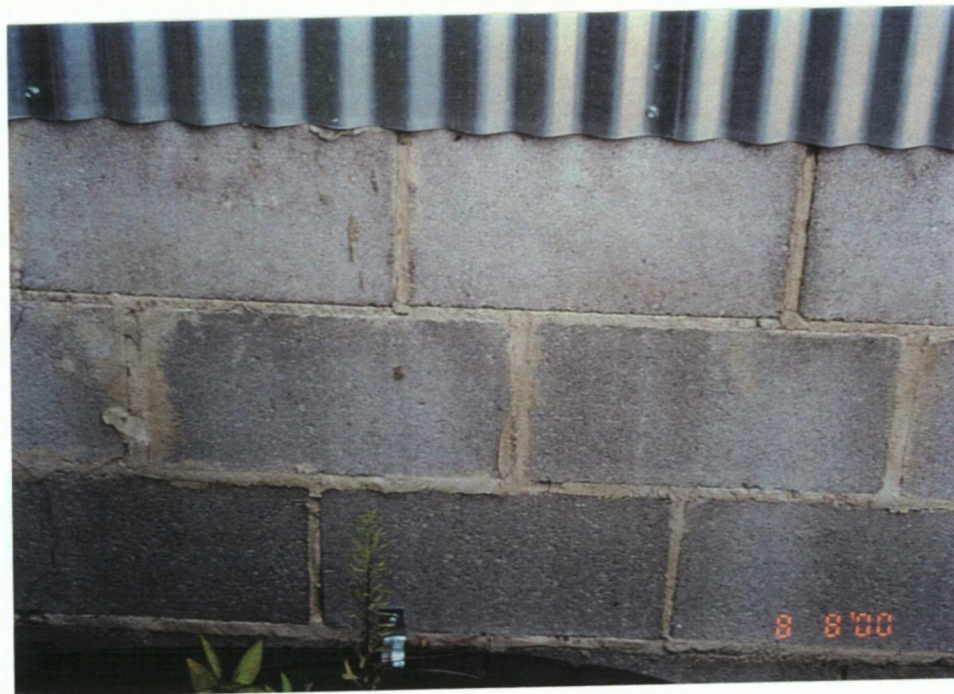
Photo 5

| Roll #1 | Photograph | Description |
|---|---|--|
| | 5. | Separation crack 8" down from siding |

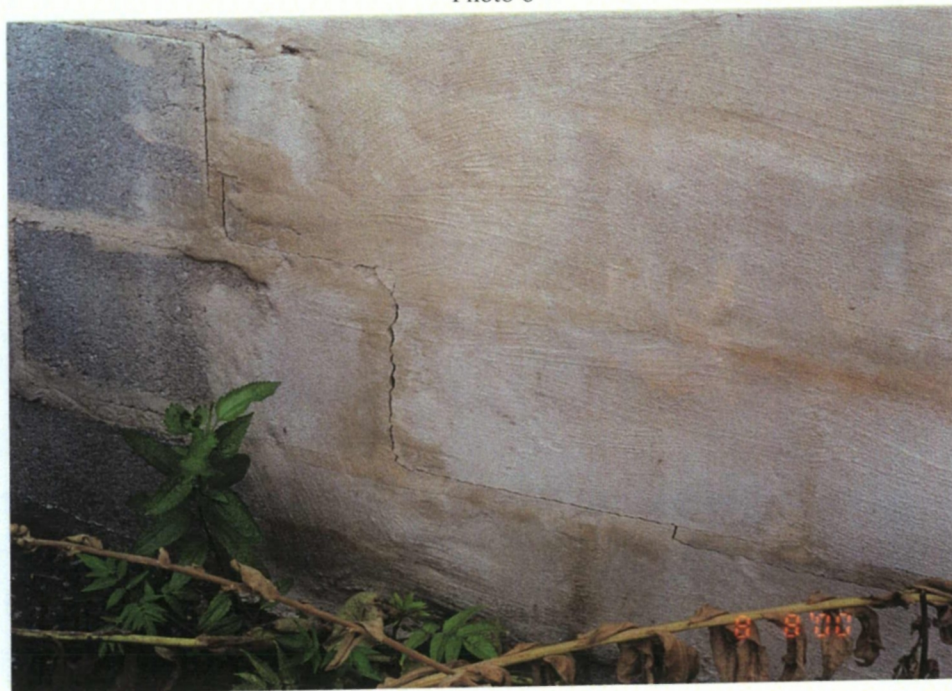
Photo 6

| Roll #1 | Photograph | Description |
|---|---|--|
| | 6. | Separation between blocks and exterior mortar ~ 9' from warehouse S. face |

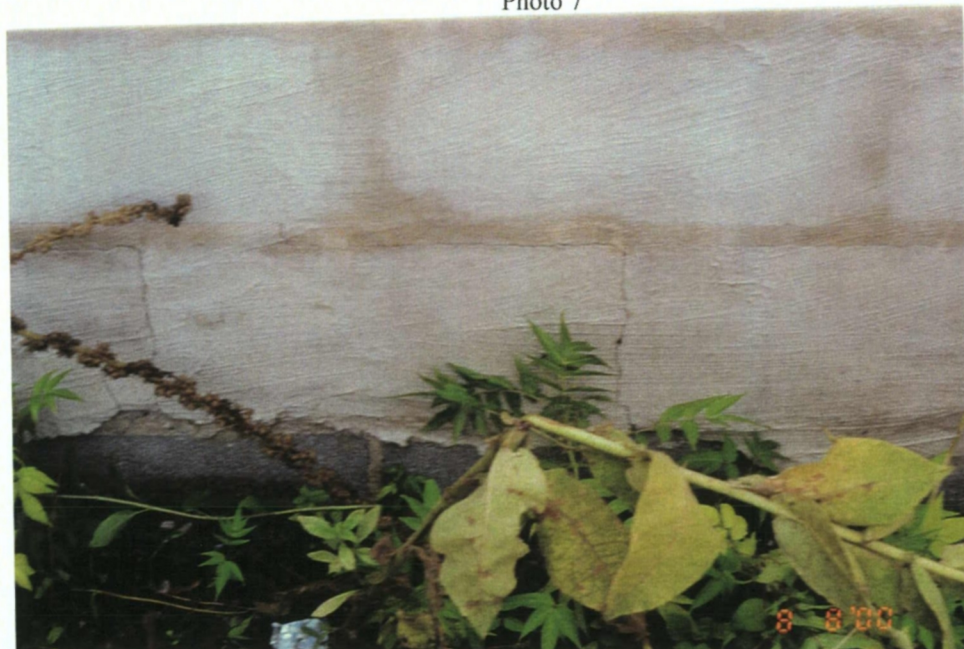
Photo 7

| Roll #1 | Photograph | Description |
|---|---|--|
| | 7. | Separation crack on addition mortar (W face) |

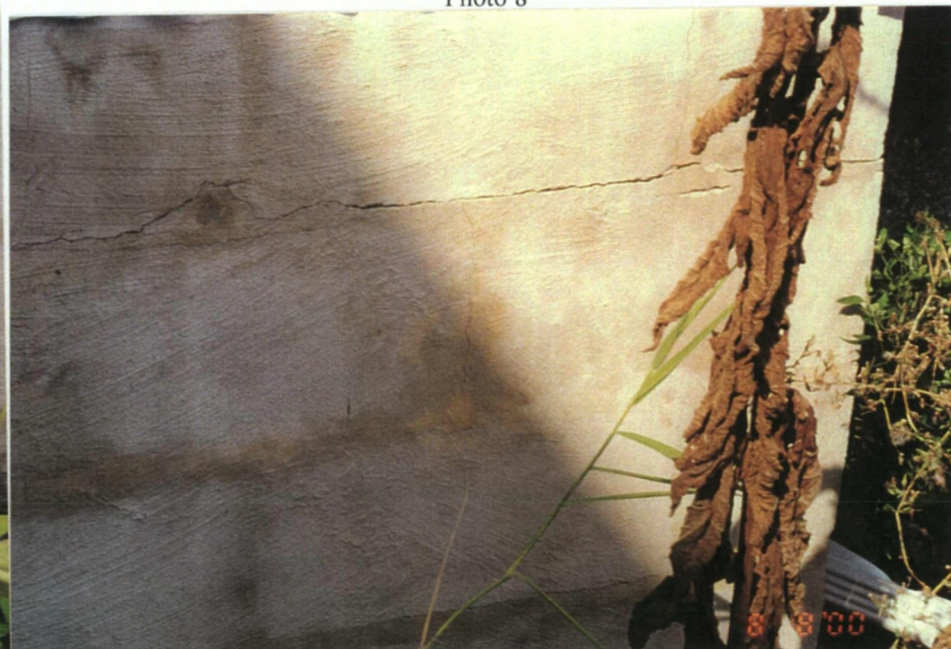
Photo 8

| Roll #1 | Photograph | Description |
|---|---|--|
| | 8. | Separation crack on addition mortar (W face) |

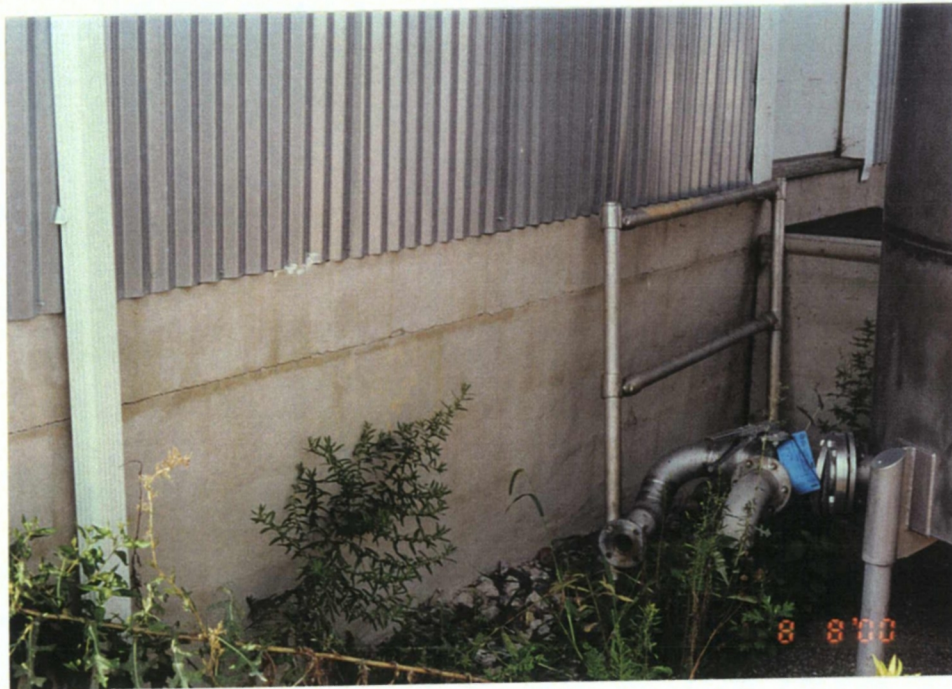
Photo 9

| Roll #1 | Photograph | Description |
|---|---|--|
| | 9. | Mortar crack S- face of addition ~ 10' long |

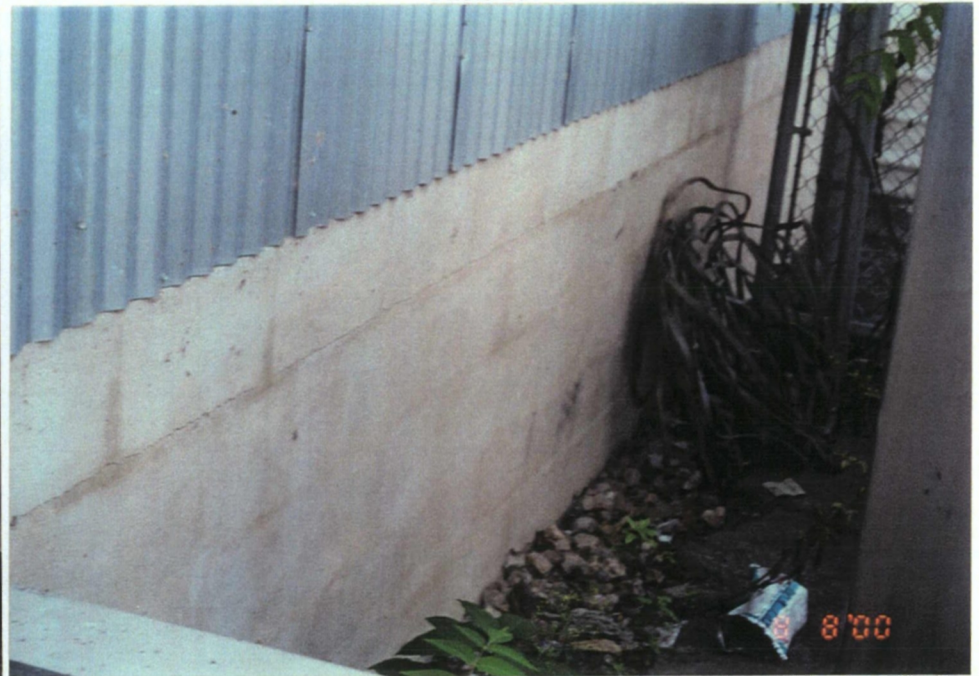
Photo 10

| Roll #1 | Photograph | Description |
|---|---|--|
| | 10. | Mortar crack S- face of addition extending the rest of the way across S face |

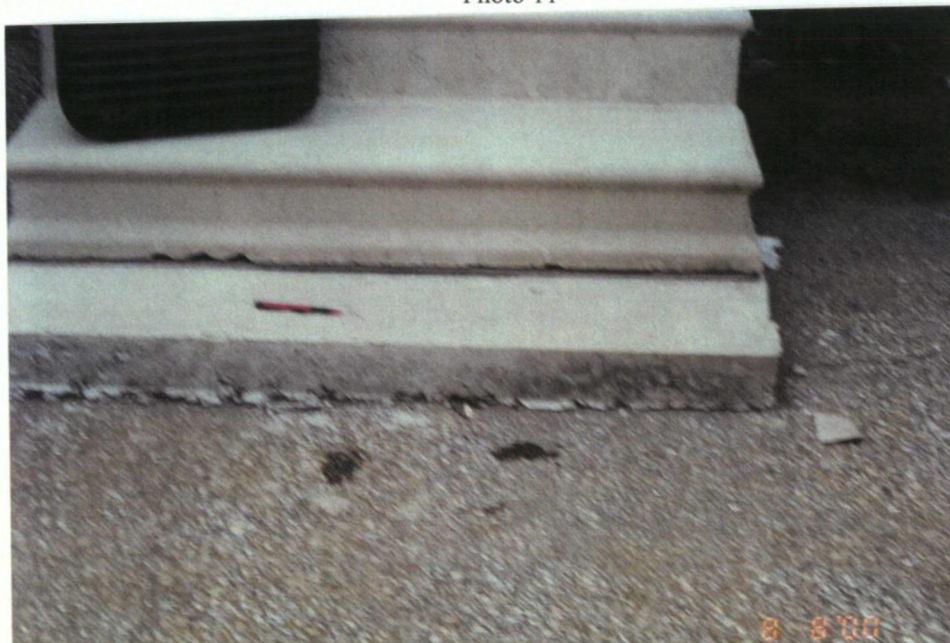
Photo 11

| Roll #1 | Photograph | Description |
|---|---|--|
| | 11. | Separation between stairs & concrete base |

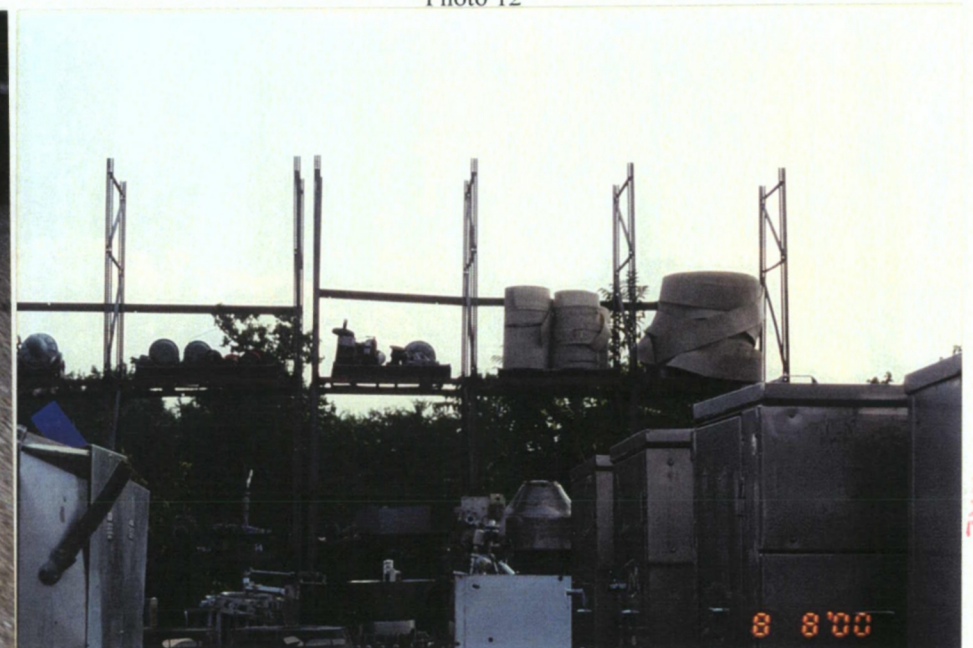
Photo 12

| Roll #1 | Photograph | Description |
|---|---|--|
| | 12. | Unstable structures in lot west side near retaining wall fence |

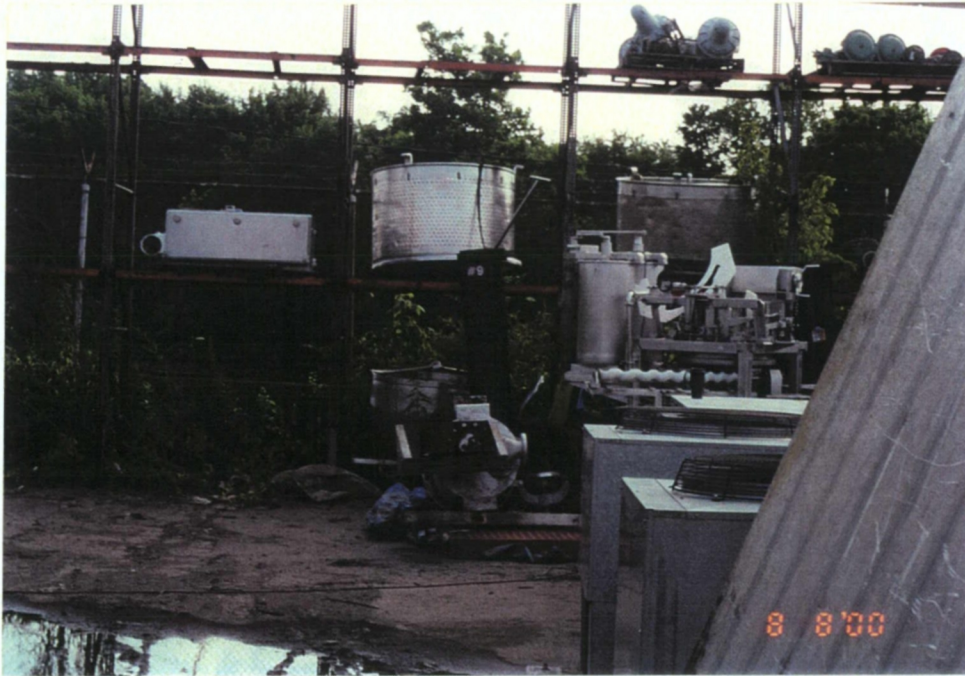
Photo 13

| Roll #1 | Photograph | Description |
|---|---|--|
| | 13. | Unstable structures in lot west side near retaining wall fence |

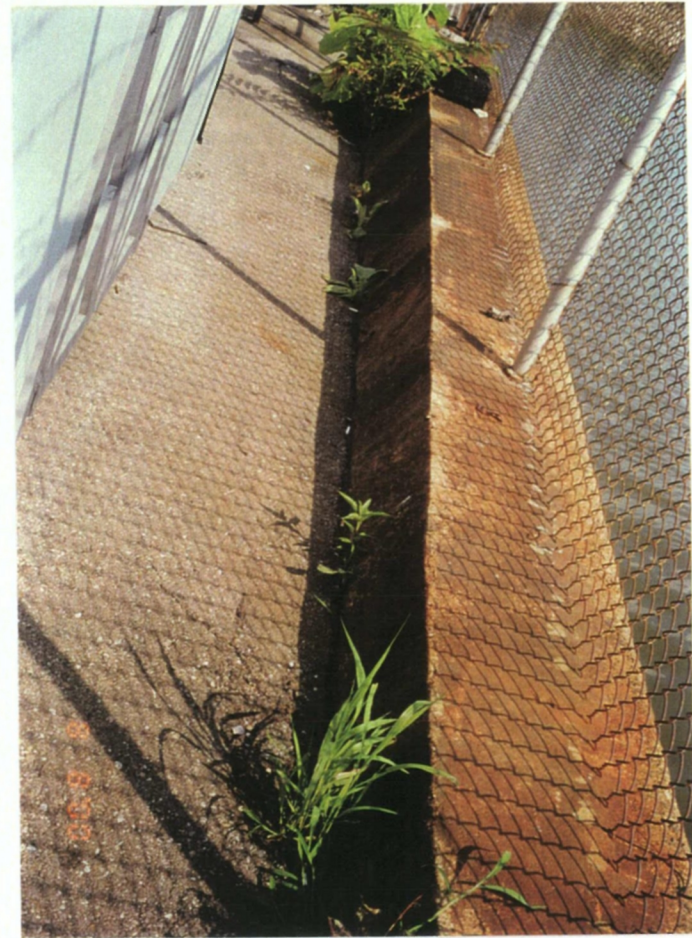
Photo 14

| Roll #1 | Photograph | Description |
|---|---|--|
| | 14. | Overview of backside of retaining wall looking N to S (rest of backside obstructed) |
